Post-test Inspection of NASA's Evolutionary Xenon Thruster Long-Duration Test Hardware: Discharge Chamber

Rohit Shastry and George C. Soulas

Presented at the 52nd AIAA/SAE/ASEE Joint Propulsion Conference

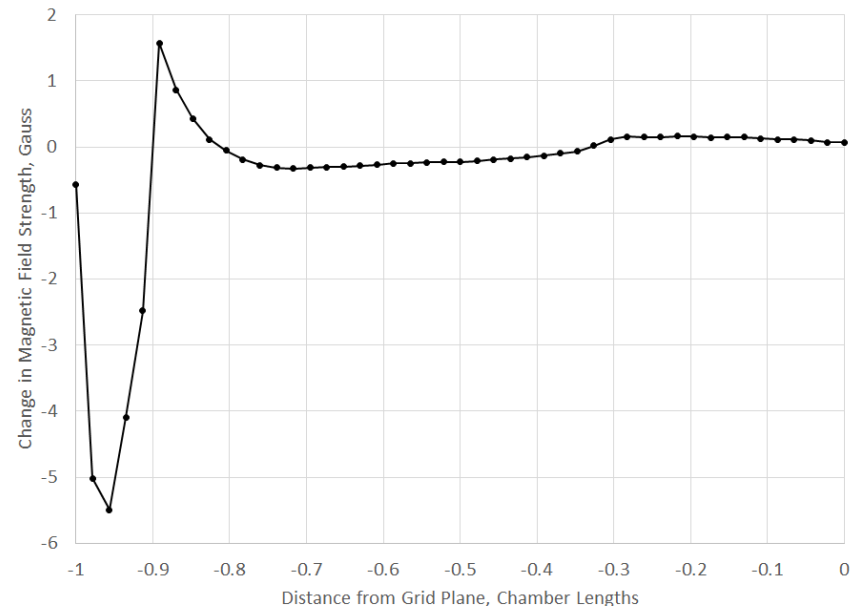
- Magnetic field measurements were taken with a 3-axis gaussmeter within the volume of the discharge chamber
 - Identical technique and equipment as pretest measurement
- Comparison of strength profile at chamber centerline indicates pretest and post-test measurements are all within 6 G of each other
- Largest discrepancies occur furthest upstream where there are large B_{mag} and $\partial B/\partial z$
 - Position uncertainty, especially of $z = 0$, could lead to larger differences in this region
- Analysis of the volumetric map as a whole shows no sign of magnetic field degradation

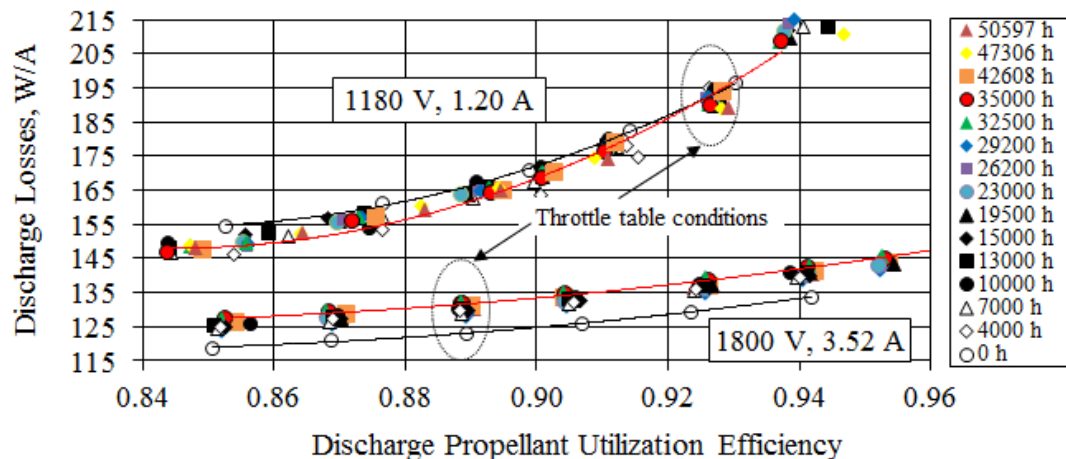
- Measurements of magnetic field strength were also made at various azimuthal locations along each magnet ring, similar to pretest measurements
 - Measurement was found to be sensitive to relative probe angle and location along discrete magnets
 - These factors were varied until the strength was maximized, yielding a repeatable measurement – however, pretest measurements were not taken this way
- When comparing maximum values along each ring, pretest and post-test measurements agree to within $\pm 6\%$, with post-test being higher most of the time
- All measurements consistent with thruster discharge performance data, indicating no magnetic field degradation

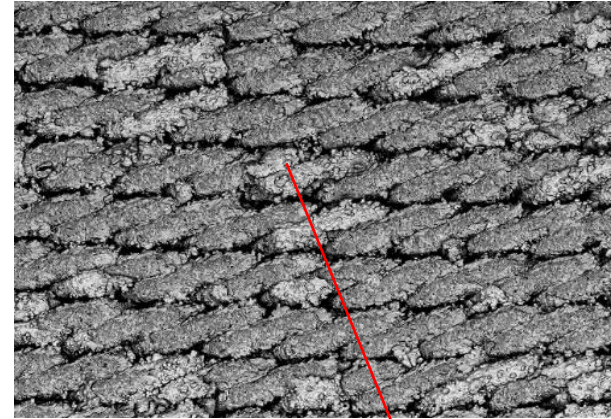
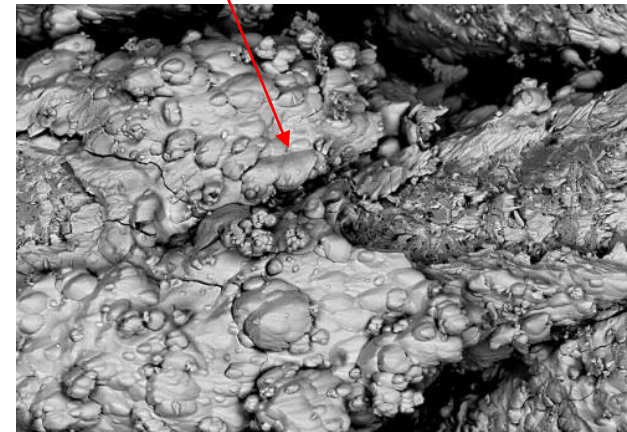
From NEXT LDT

- Discharge chamber mesh samples were removed at various axial locations and a fixed azimuthal location (axisymmetry of deposition assumed)
- Deposition coating evident in photomicrographs of mesh
- Energy dispersive x-ray spectroscopy indicates this coating is primarily grid material, although numerous nodules within mesh had high carbon content
- Similar results were found in NSTAR ELT

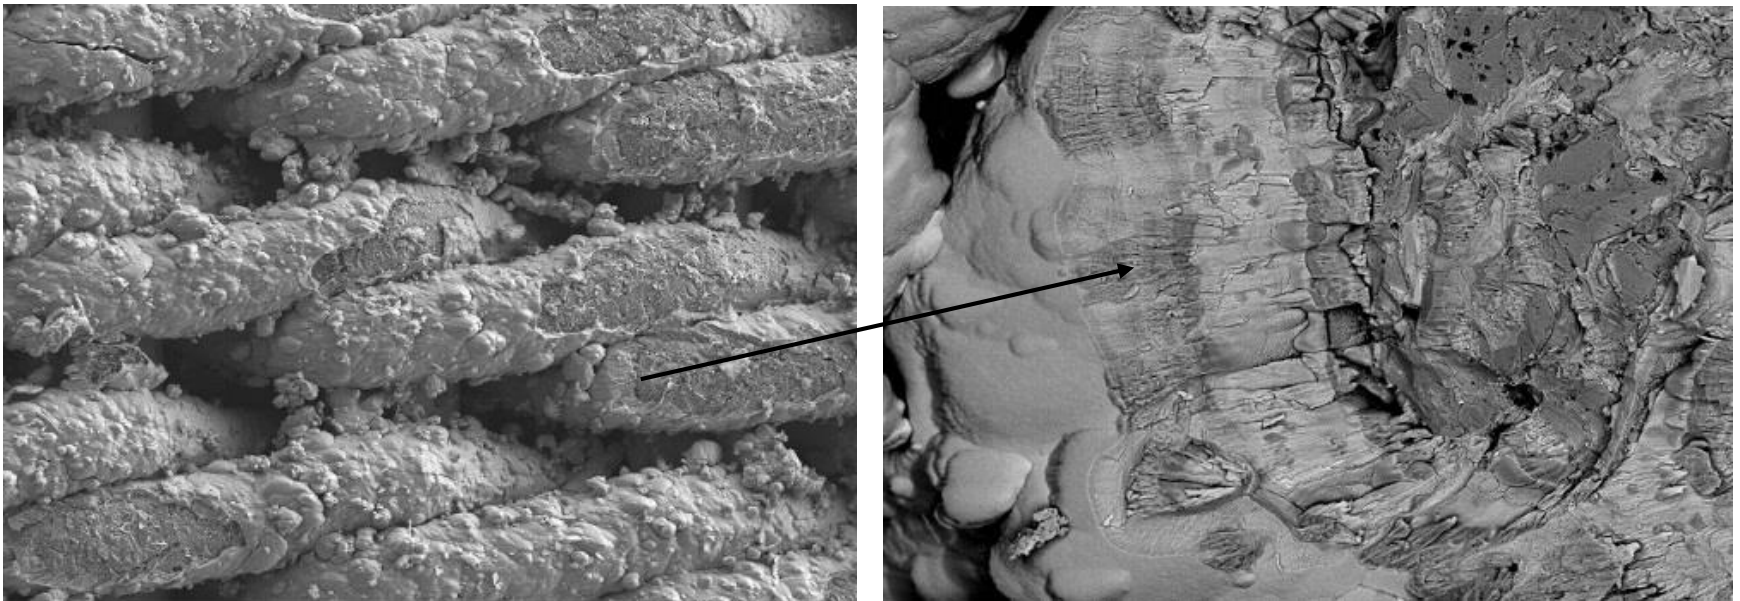
- Samples of discharge chamber mesh further upstream showed deposition with broken edges
 - Could be due to spalling or handling of sample during inspection
- Broken edge shows layered deposition
 - Backscattered electron image indicates light layers are primarily grid material and darker layers have more carbon content
- Estimate of deposition thickness from broken edge $\sim 15\text{ }\mu\text{m}$, which is well below estimated maximum deposition thickness that can be retained by mesh

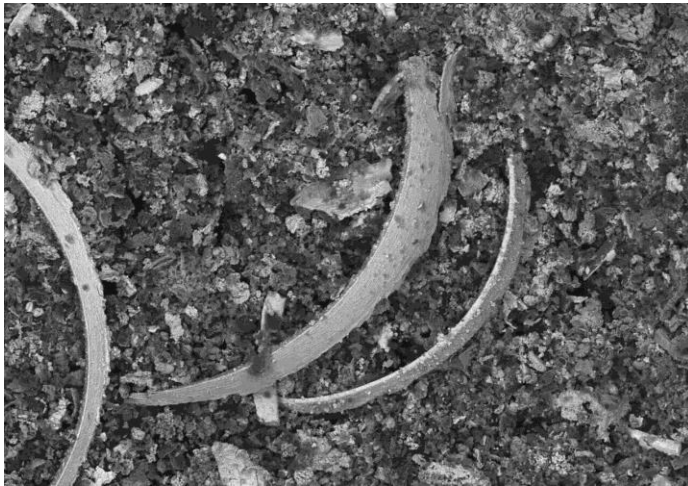
From NEXT LDT

- A large number of flakes were found at the bottom of the discharge chamber
 - Similar result to NSTAR ELT
- Numerous samples were taken, and a total of ~ 3.1 grams of material was collected from the discharge chamber
- Many of the largest flakes exhibited a semi-circular shape
 - Radius of curvature of these flakes indicate they had come from the accelerator grid apertures – similar result to NSTAR ELT
- Flakes were comprised of a combination of grid material and carbon

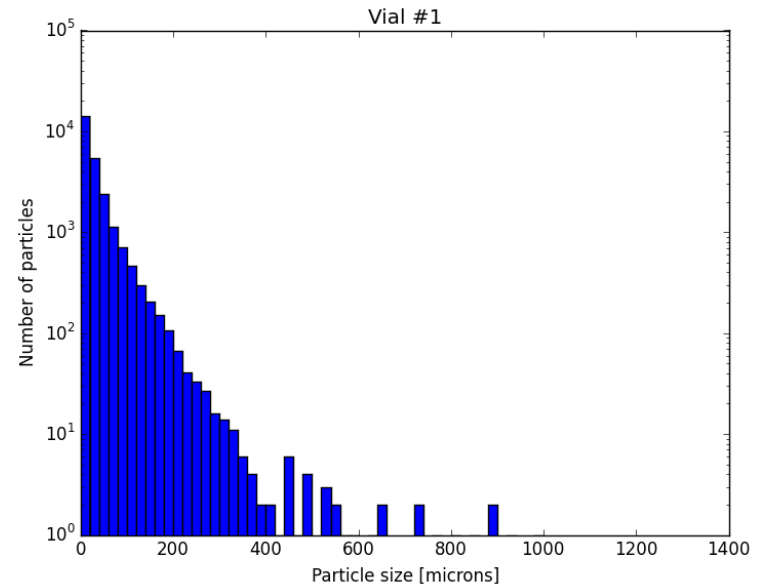
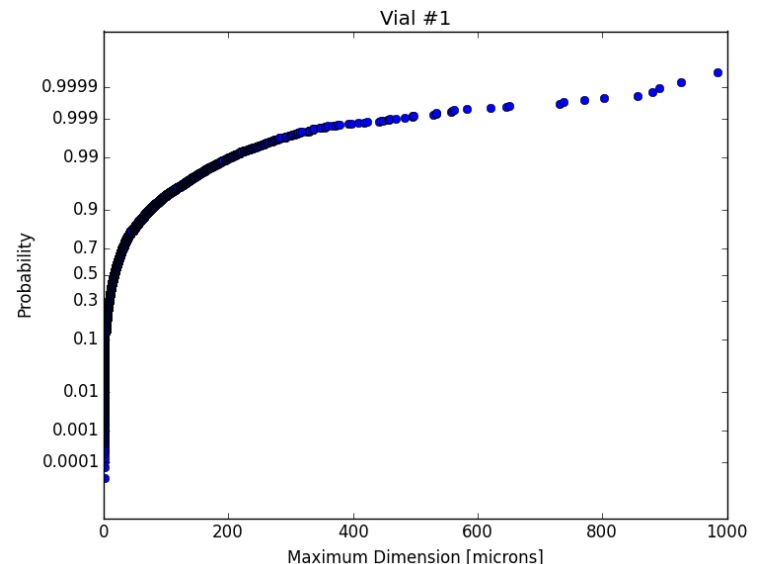
- Samples of flakes from different axial locations were analyzed to determine size distributions
 - Need to quantify likelihood of forming flakes large enough to short grids
- Histograms indicate that 99% of flakes have a largest dimension $< 200 \mu\text{m}$
- However, flakes do exist that are large enough to cause a grid-to-grid short
- NSTAR ELT also found large flakes, but determined that these flakes originated from the facility so should not be an issue in flight
 - Similar analysis on large flakes for NEXT LDT is presently underway

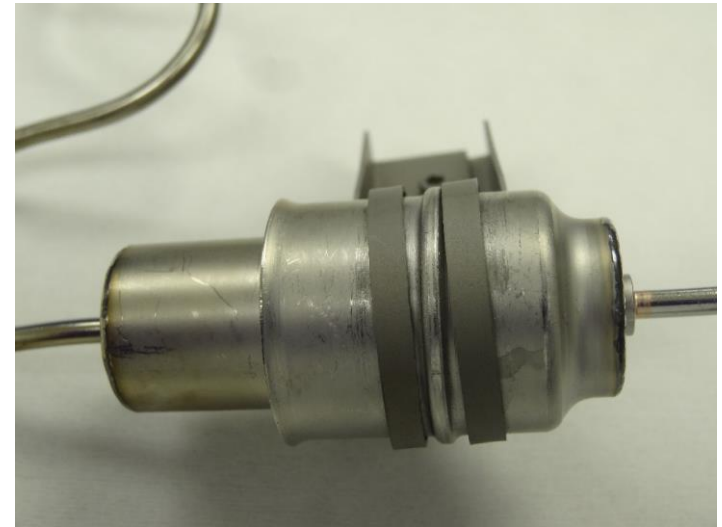
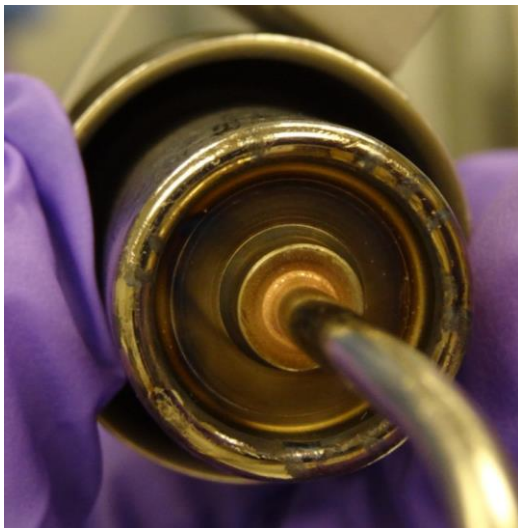
- HVPIs for both main and discharge cathode lines were inspected for leaks and impedance degradation
- No leaks were found, and both HVPIs had impedances $> 300 \text{ G}\Omega$ at 1800 V applied voltage

- Only visual change on casing was discoloration on downstream end of discharge cathode HVPI
 - Cause is unknown, but was not an issue
- Destructive disassembly of both HVPIs revealed all insulators to be clean with no signs of internal arcing

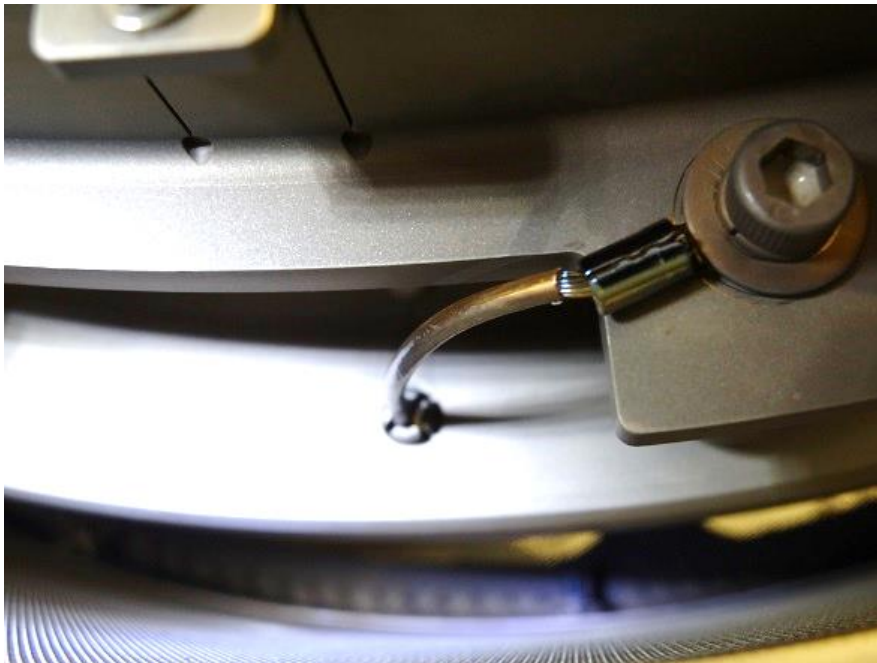
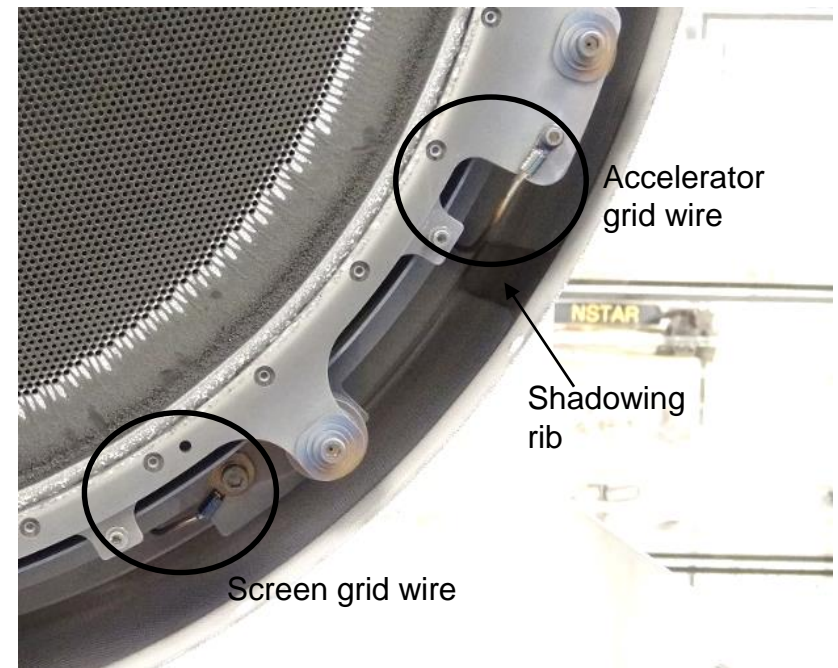
- Low impedance between screen grid and anode was observed during test, and dropped to 40-50 k Ω by the end of the test
- Cause was traced to deposition on screen grid wire as it passes through discharge chamber from rear of thruster (verified with resistance measurements)
- Elemental analysis indicated this deposition is primarily backspattered carbon from the facility that had come through the perforated plasma screen
- Cylindrical plasma screen is solid in latest thruster design, so this issue is not expected to occur in flight or in future ground tests
